**BEFORE THE
FEDERAL COMMUNICATIONS COMMISSION
WASHINGTON, D.C. 20554**

Reply Declaration of Michael T. Harrelson, P.E.

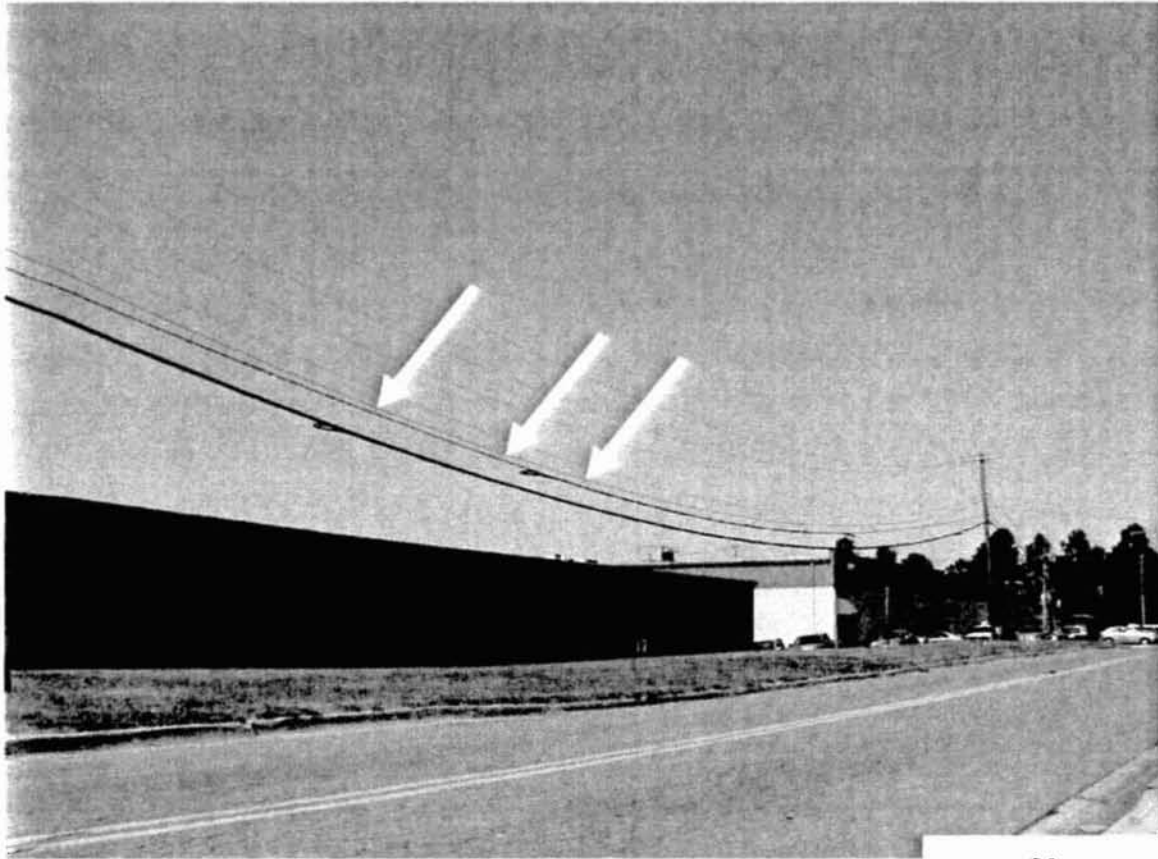
- 8A -

This photo, which I took, shows a very common problem which cannot reasonably be solved without the full cooperation of EAI. Before any other work can be done by any other party, EAI first must correct the impermissibly low sag in its electric lines (Arrows). After that is done, communications cables sags can be adjusted for proper separation from power and proper clearance from ground, if either adjustment is necessary. The proper cable separation for the cable television facilities from power cannot be determined until after power resags. This is an important example of how the pole owner must work with the pole occupants to fix complex safety issues. Location: Little Rock Enmar Dr.

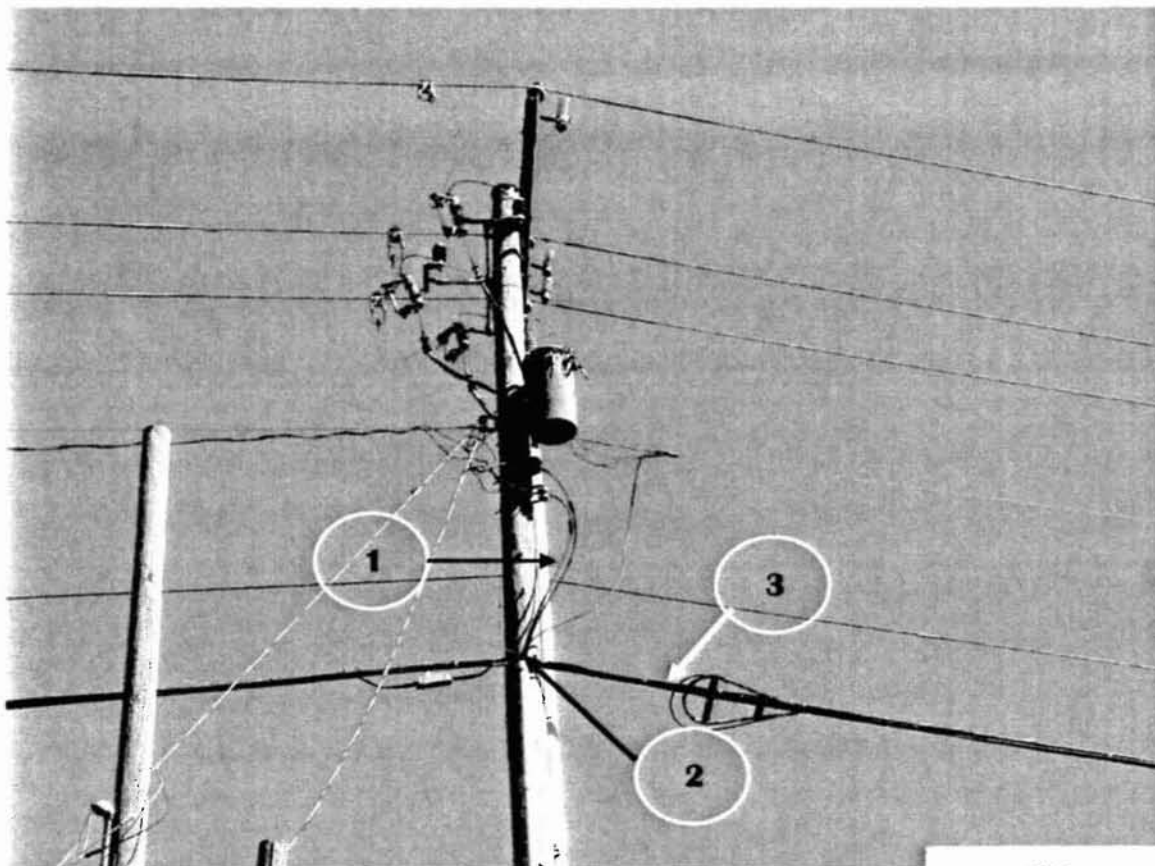
- 11A -

In this photo, which I took, EAI placed an underground service up the pole outside cable (Arrow #1). As a result, the cable operator cannot move or work on this cable without the assistance of power company crews. The Comcast cable is pinned to the pole by electric wires (Arrow #2) which, by code, should be 40" above the cable television line (the bottom black line with the fiber "snow shoe" (Arrow #3)). It is obvious from the position of these facilities that cable was installed first. Despite pleas from Comcast, EAI still has not corrected this clear hazard. Location: Little Rock University Ave.

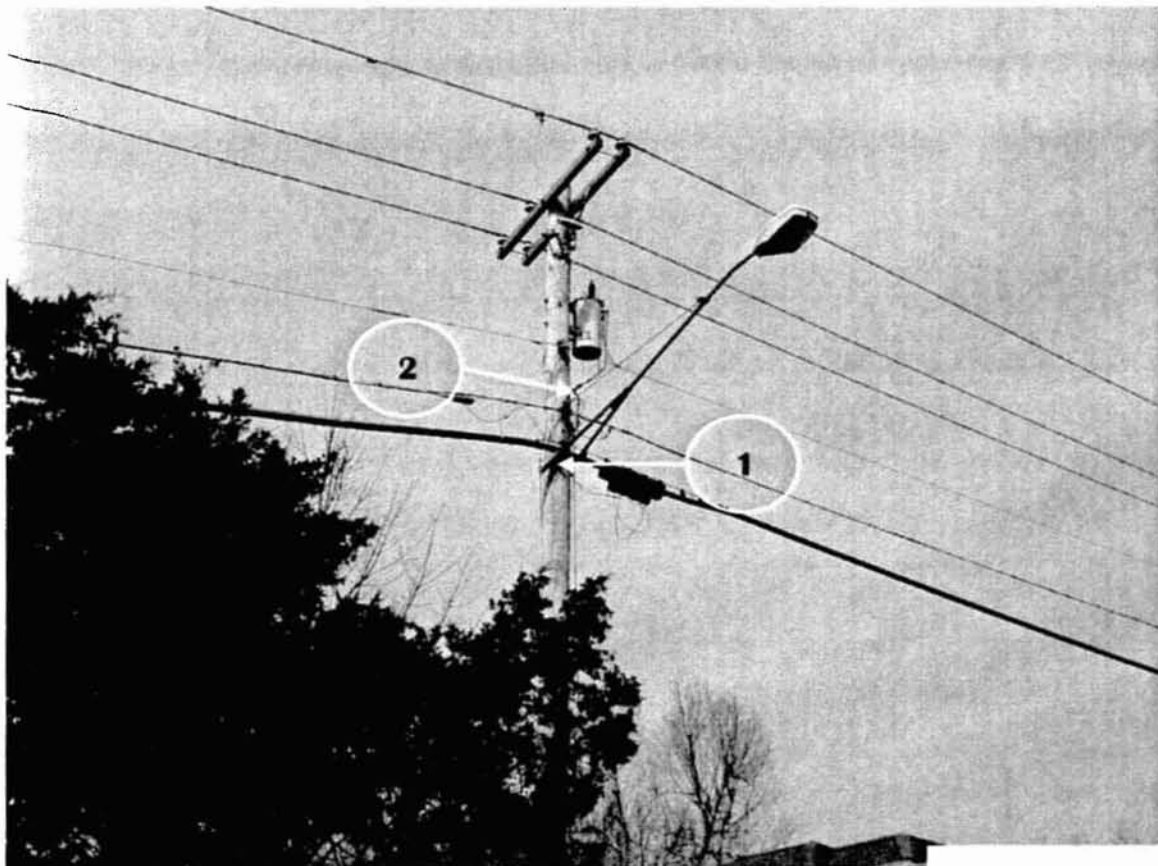
- 12A -

This photo, which I took, shows an EAI street-light bracket installed both below the telephone facilities (Arrow #1) and above the cable television facilities (Arrow #2). It is very obvious that this street light bracket could not have been installed before the cable television and telephone attachments because the street light brackets are installed *on top* of the communications facilities. This is one of what I would estimate to be many thousands of examples in Arkansas that contradict EAI's central assertion that electric facilities always came before cable. Location: Jacksonville, AR, N. First St.

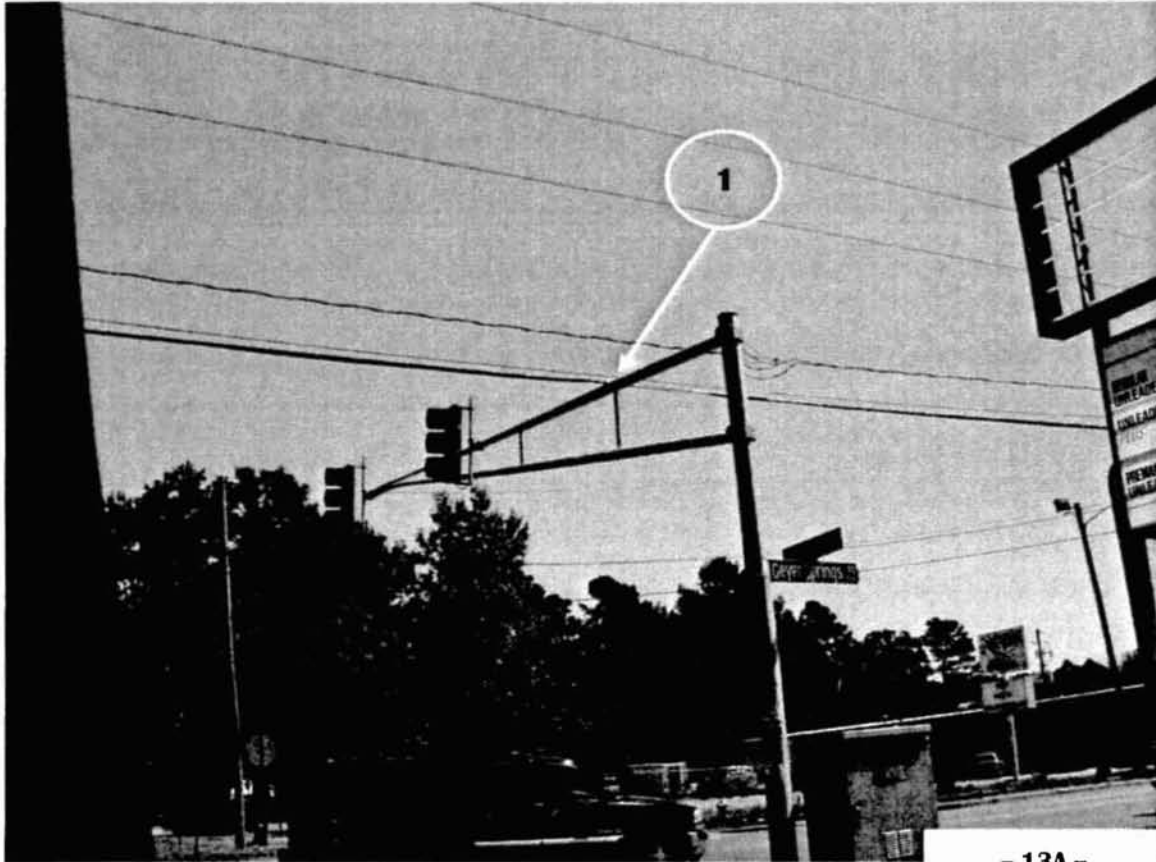
- 13A -

This photo, which I took, shows a common problem throughout Little Rock where new traffic signals are installed on long horizontal arms over the roadway by governmental agencies. In so doing they push the cable and/or telephone facilities up, often creating violations with cable tv, telephone and electric lines (Arrow #1). These types of problems need cooperation and good communications directed and facilitated by the power company. Location: Little Rock Geyer Springs Rd. at Forbing Rd.

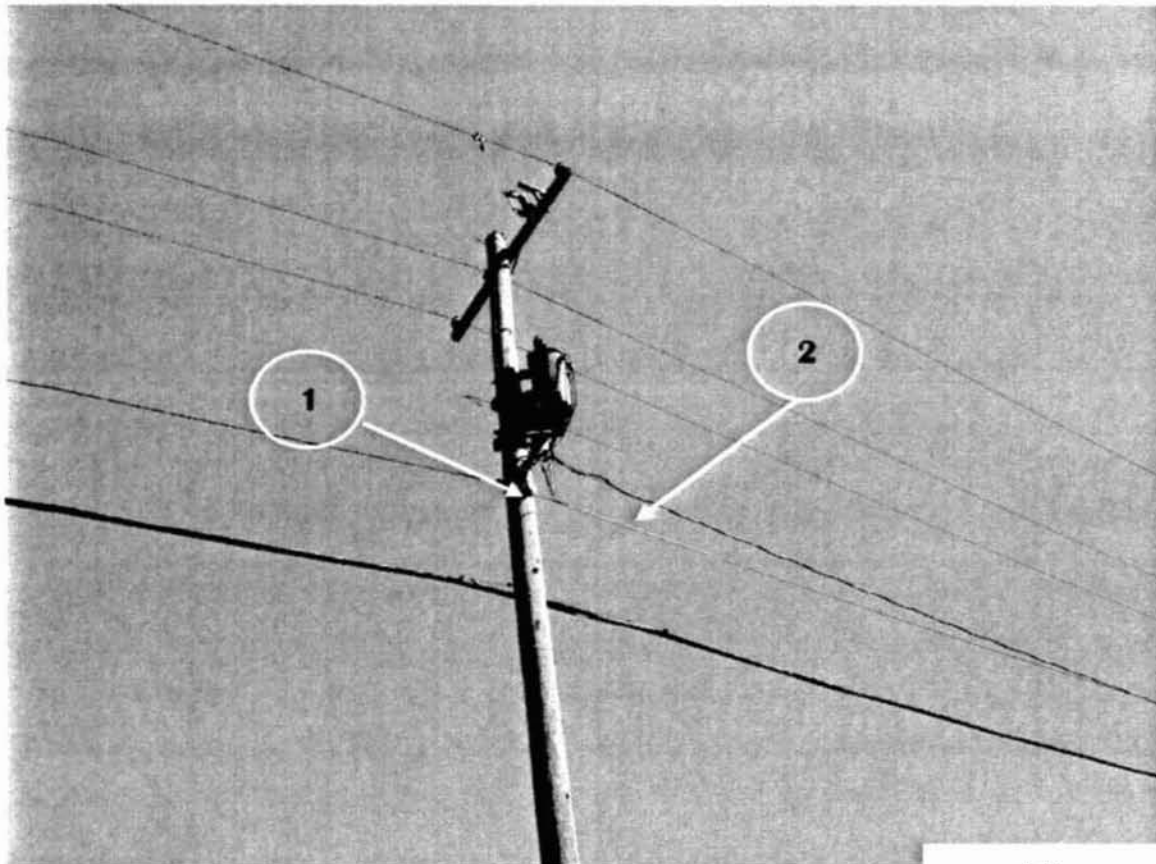
- 14A -

In this photo, which I took, EAI has installed a new flood light bracket (Arrow #1) below a fiber-optic cable (Arrow #2) now owned by a competitive telecommunications company as well as triplex secondary to the light on the next pole installed by EAI in violation. As is pointed out elsewhere Entergy installed this fiber optic cable (Arrow #2) in clear violation of the NESC at a time in which it was a part owner of the fiber venture that used to own this fiber strung throughout Little Rock (often in violation). Location: Little Rock University Ave.

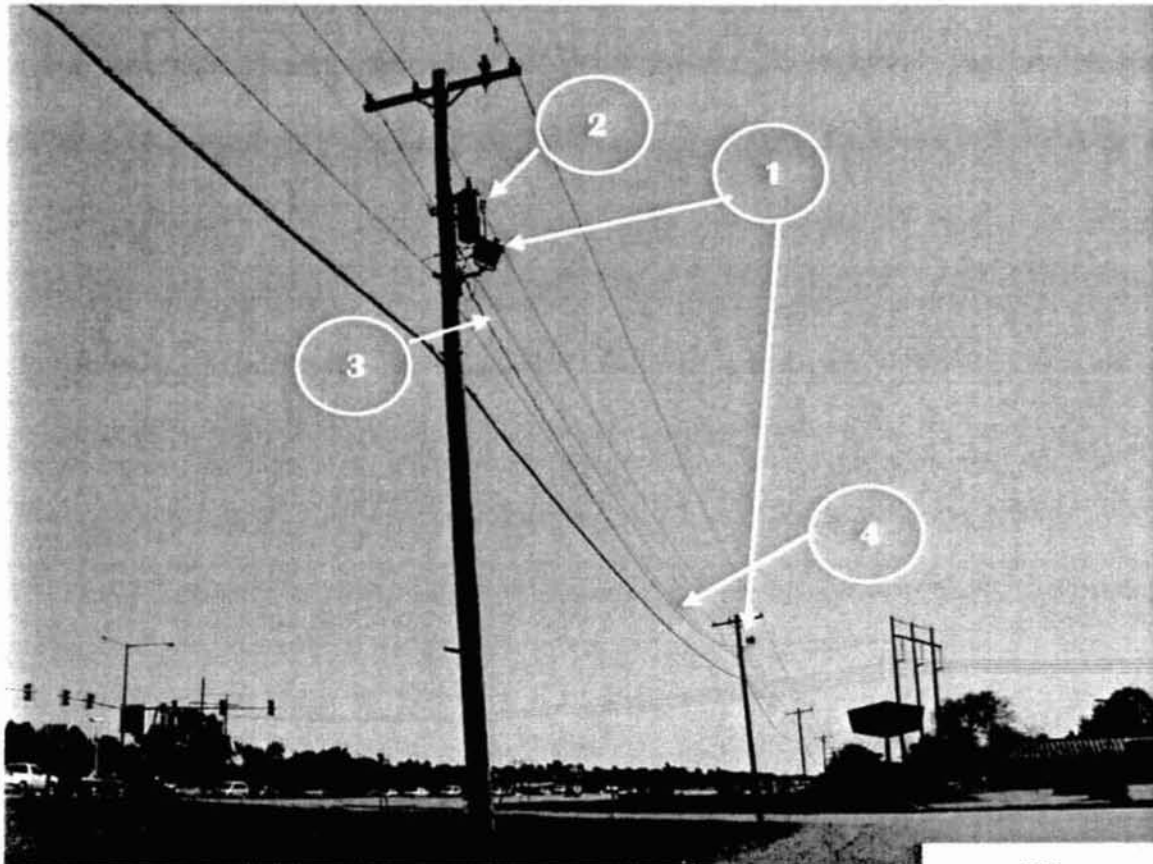
- 15A -

In this photo, which I took, the new flood lights on both of the poles shown (Arrows 1) are the only things served by the transformer (Arrow #2). This indicates that all these facilities were placed long *after* cable was in place. (I address this issue in greater detail when considering ACTA's False premise Number 3) EAI's triplex wire (Arrow #3) from the transformer pole hangs *below* the fiber-optic (Arrow #4) in the span in violation. It should be 30" *above* this fiber-optic cable. A fiber optic cable may be installed in the electric supply space (if non-conducting) or in the communication space but not in between, which is the communications worker safety zone. These fiber-optic facilities used to be part-owned by Entergy. Location: Little Rock University Ave.

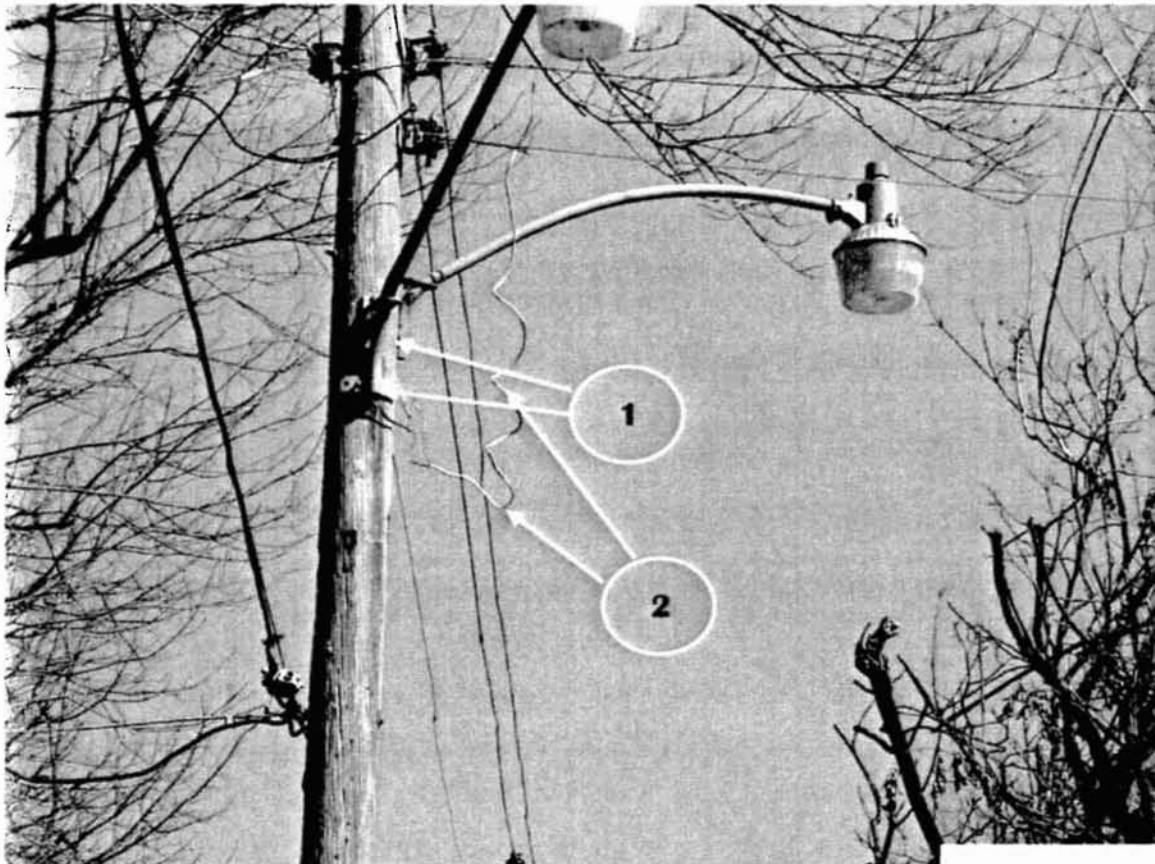
- 17A -

This photo, which I took, shows two street lights. The brackets are not grounded (Arrow #1). This violates EAI construction standards which are shown in the diagrams attached to some of its agreements. Even though EAI and USS purport to be concerned about plant safety, USS did not check for this EAI violation. Twenty inches of separation is required for un-grounded street light brackets. In addition, the "romex" type wire to power the lights hangs down beside the pole in violation (Arrow #2). Location: Little Rock 10th St rear of 928 Townsend St.

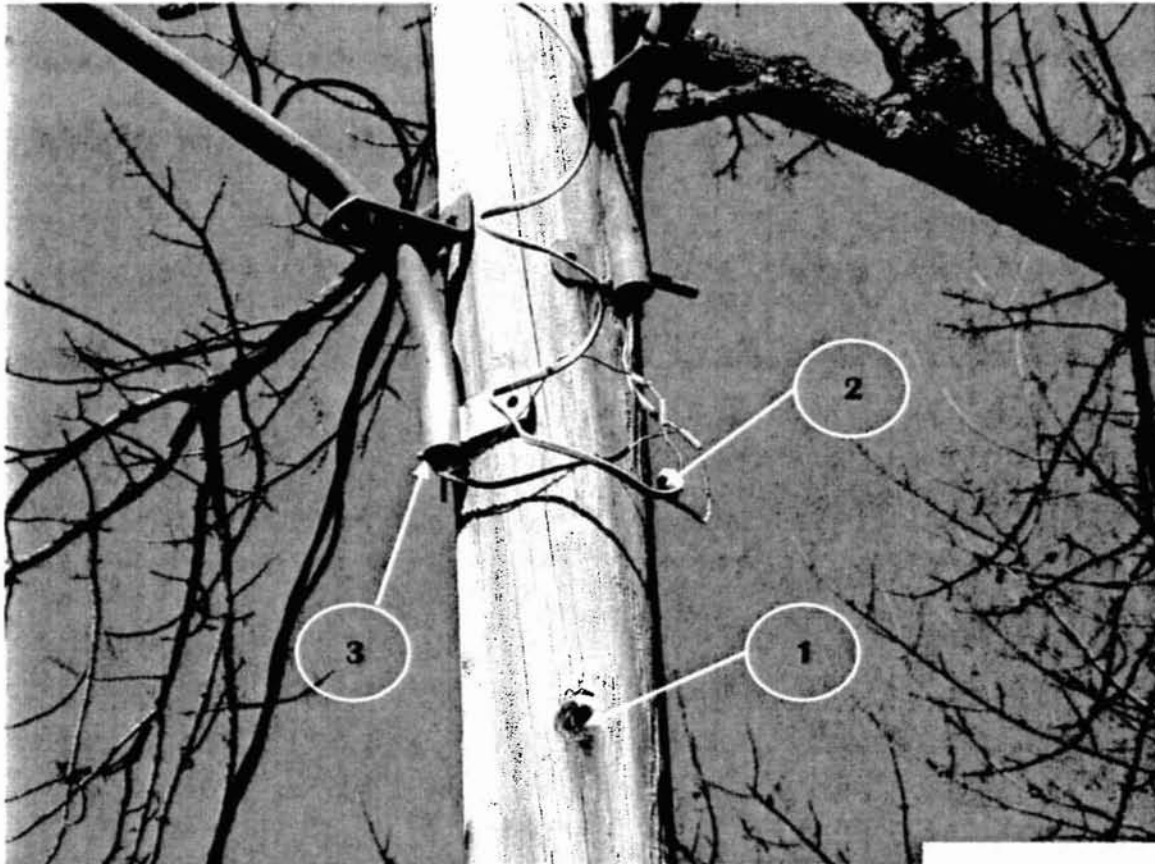
-- 18A --

This photo, which I took of the same two lights, shows the old bolt location (Arrow #1) where Comcast cable attachment previously was located less than 12" below the light leads (Arrow #2) and less than 20" below brackets not grounded (Arrow #3). Comcast visited this pole to resolve a guying problem which USS had notified Comcast to correct. USS had notified EAI to raise light leads to 12" above cable but nothing else. While correcting the guying, Comcast lowered its cable to obtain NESC compliance from the ungrounded brackets and low light leads which EAI had not yet raised. These violations still exist and must be corrected. Location: Little Rock 10th St rear of 928 Townsend St.

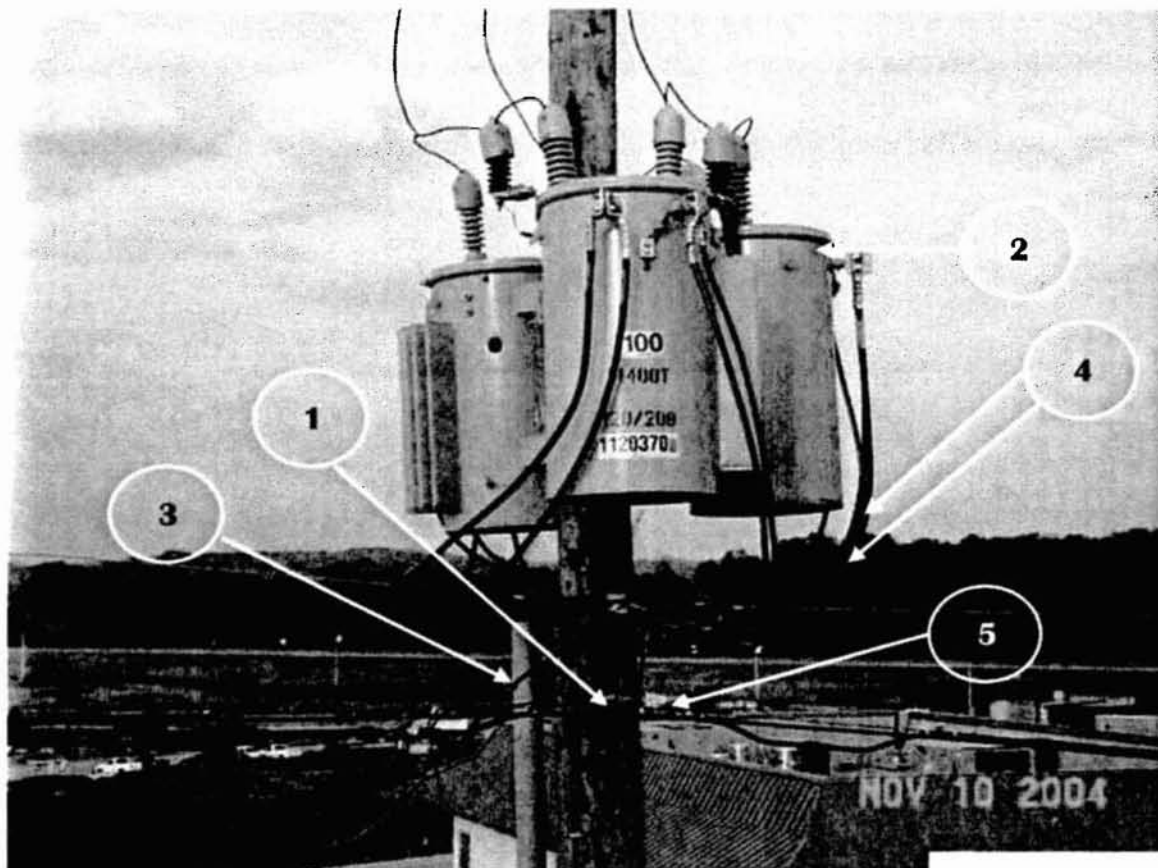
-- 22A --

One of Entergy's central contentions is that electric facilities always are on the poles first and that cable facilities always come later. This is so it can argue that whenever there are clearance violations, they have been created by cable. This photo shows that this is not true. The three-phase transformer bank depicted in this photo were installed within the last several months to provide electric service to a new McDonalds restaurant. The poles and the cable television attachments (Arrow #1) were installed before the offending riser conduits and transformers. Cox was attached in compliance. The new transformer cans (Arrow #2) the grey "riser" conduit (Arrow #3) and the electric wires (Arrow #4), were installed after cable. There are no more than a few inches of separation between the hot electric wires coming out of the riser (Arrow #3) and Cox's facilities (Arrow #1). The NESC mandates that there should be 40 inches between the riser cable and the Cox attachment. I believe that this pole was set by EAI to provide adequate vertical clearance above the new driveway at the McDonalds. These photos were taken at the direction of Jeff Gould of Cox.

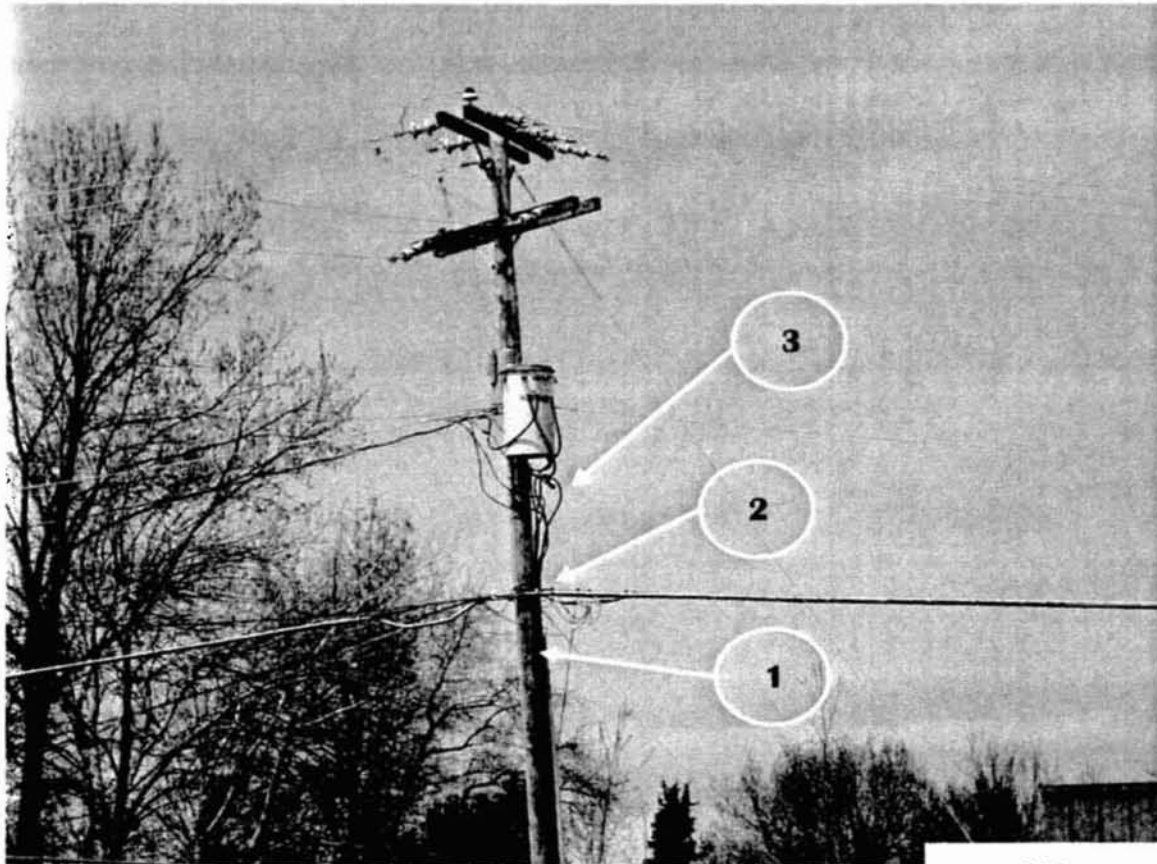
- 23A -

This photo, which I took, presents another good example. It shows an EAI secondary underground service riser pipe (Arrow #1) stopping more than 12 inches **below** the cable television facilities (Arrow #2) located on this pole. The NESC requires this electric conduit to be 40 inches above cable. You can see that there are two underground service drops running from the transformer and the loops coming out of the transformer are very sloppy (Arrow #3). Putting the proper length of conduit and placing the loops correctly could have been done easily. Underground service risers such as these are usually added long after the cable television facilities have been installed. Other examples of poorly installed electric facilities that went in long after cable appear in the next photo. Location: Jacksonville, AR Alley between N. Bailey Blvd & N. James St.

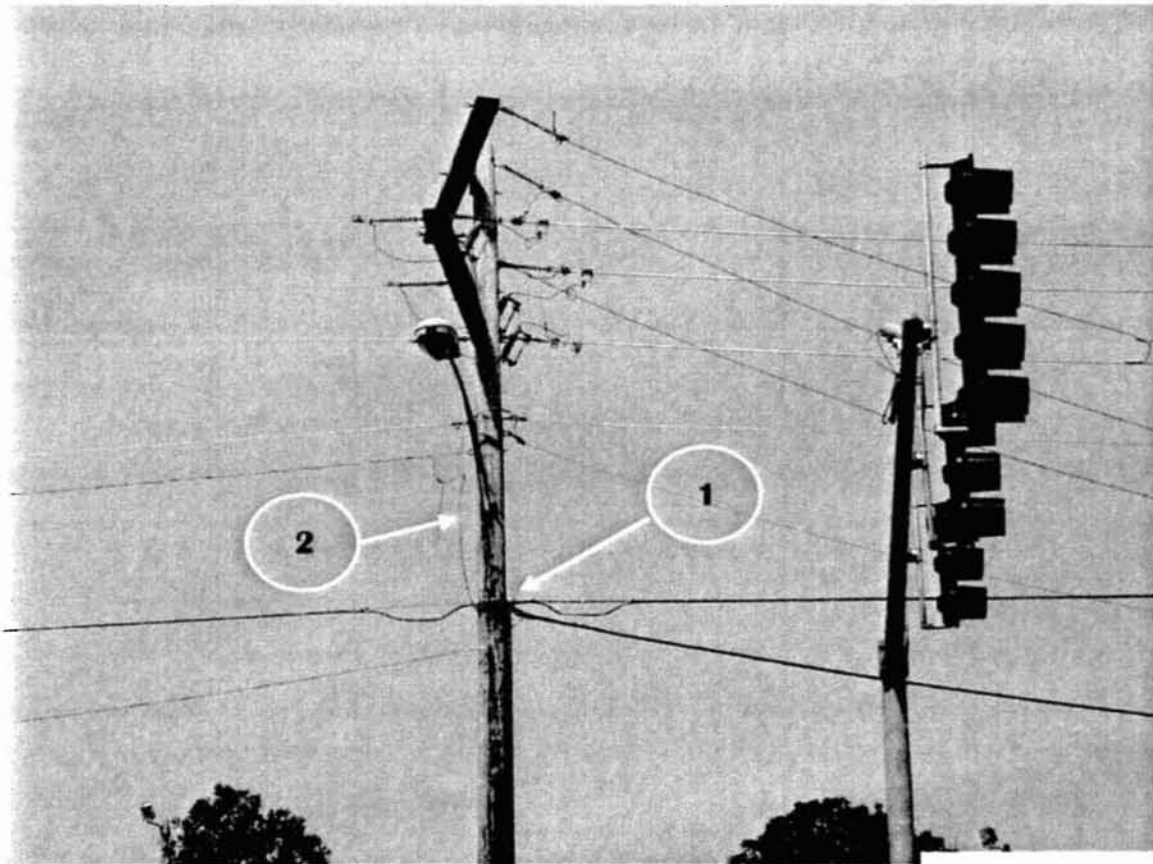
- 24A -

This photo, which I took, shows an EAI service to a new traffic signal. Electric power to supply the traffic signal is wired by the governmental agency or contractor. Metal conduit with two wires for 120 volt power is extended up this pole (Arrow #1). In this case, EAI should not have made this connection because of this NESC violation, and required the conduit owner to extend the conduit to 40 inches above cable television. You can see several exposed wires hanging beside the pole next to EAI's secondary on the left of the pole (Arrow #2). This is a blatant violation of the NESC's 40 inch rule. Connections to a new service (in this case traffic) must be 40 inches above cable. EAI should remedy this by placing a "u-guard" (which is essentially one-half a plastic conduit over the traffic signal leads, or require the owner of the traffic signal to extend the weather head up to 40 inches or more above cable. Location: Jacksonville, AR W Main St at N. Bailey Blvd.

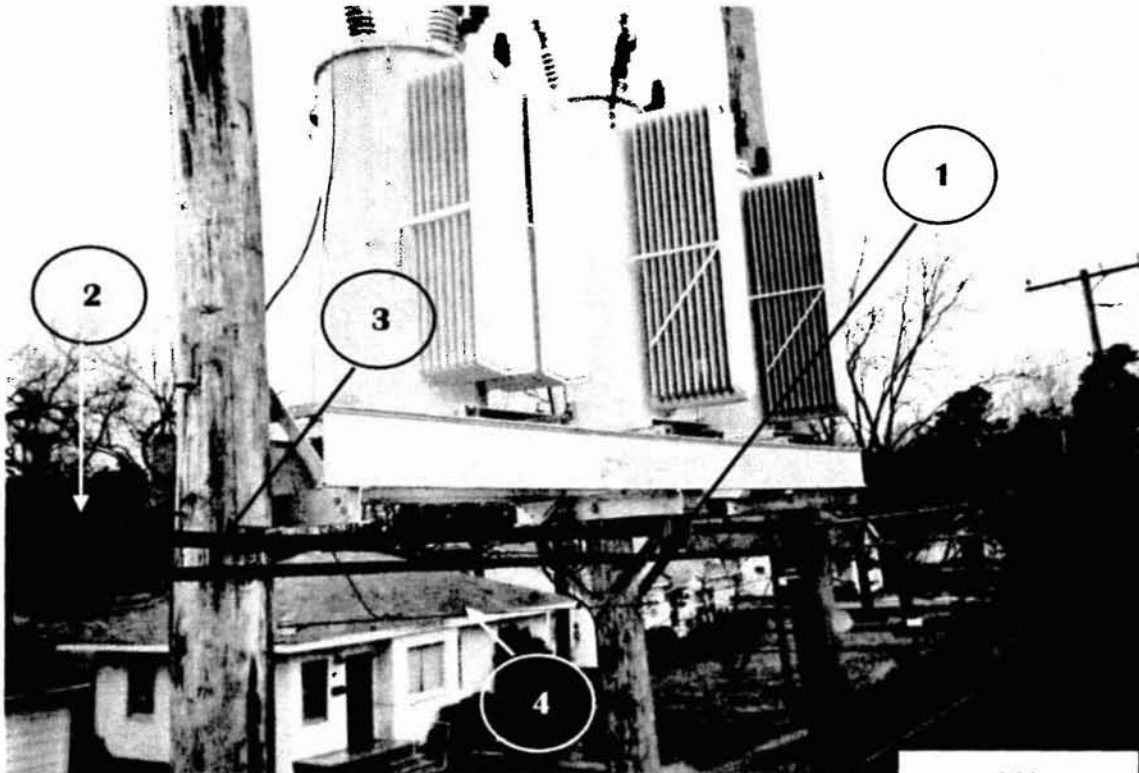
- 26A -

This photo, taken at the direction Jeff Gould of Cox Communications, shows a multi-pole platform-mounted voltage regulator that Entergy has installed *after* the installation of communications facilities. Note on the center pole the steel bracket (Arrow #1) that has completely boxed in the two sets of communications lines on the poles. The top line is the cable attachment (Arrow #2). EAI set new poles, pulled Cox's cable down and physically forced it beneath a bolt through one pole (Arrow #3). EAI built its neutral wire below the telephone cable (Arrow #4). Neither cable tv nor telephone is attached to either pole or bonded to the pole grounds. This creates a very dangerous situation. In installing these facilities Entergy has violated NESC rules, cable tv, telephone and EAI standards. This photo shows that EAI has a lack of understanding of the NESC, lack of training, no inspection of new construction and a complete disregard for users of the communications space. Electric companies, like communications companies from time to time must add new facilities to their networks. But they must do so in a way that respects the rights of others to occupy the poles, including providing adequate notice of the work that they wish to perform on the poles.

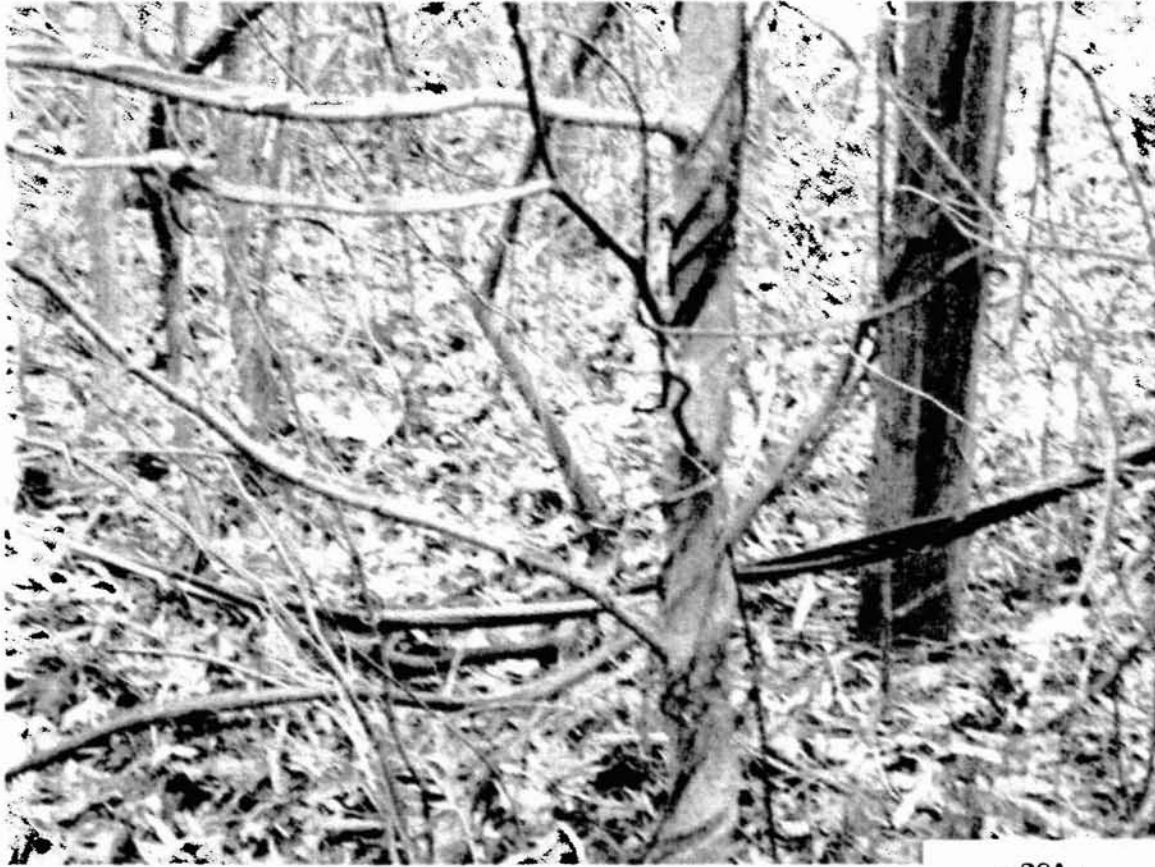
- 38A -

This photograph, which was taken at the direction of Comcast's Marc Billingsley, shows a hot EAI electric service lying on the ground of some woods near a residential area in Little Rock. This hazard was initially reported to EAI by USS during its "safety audit." Comcast discovered it during a follow up engineering trip to the pole, identified by USS. Entergy still had not reattached it to the pole as of June 7, 2005. A hot wire on the ground is a serious hazard to the public. This illustrates a major clear disconnect between EAI's claimed emphasis on safety and its trouble response department.

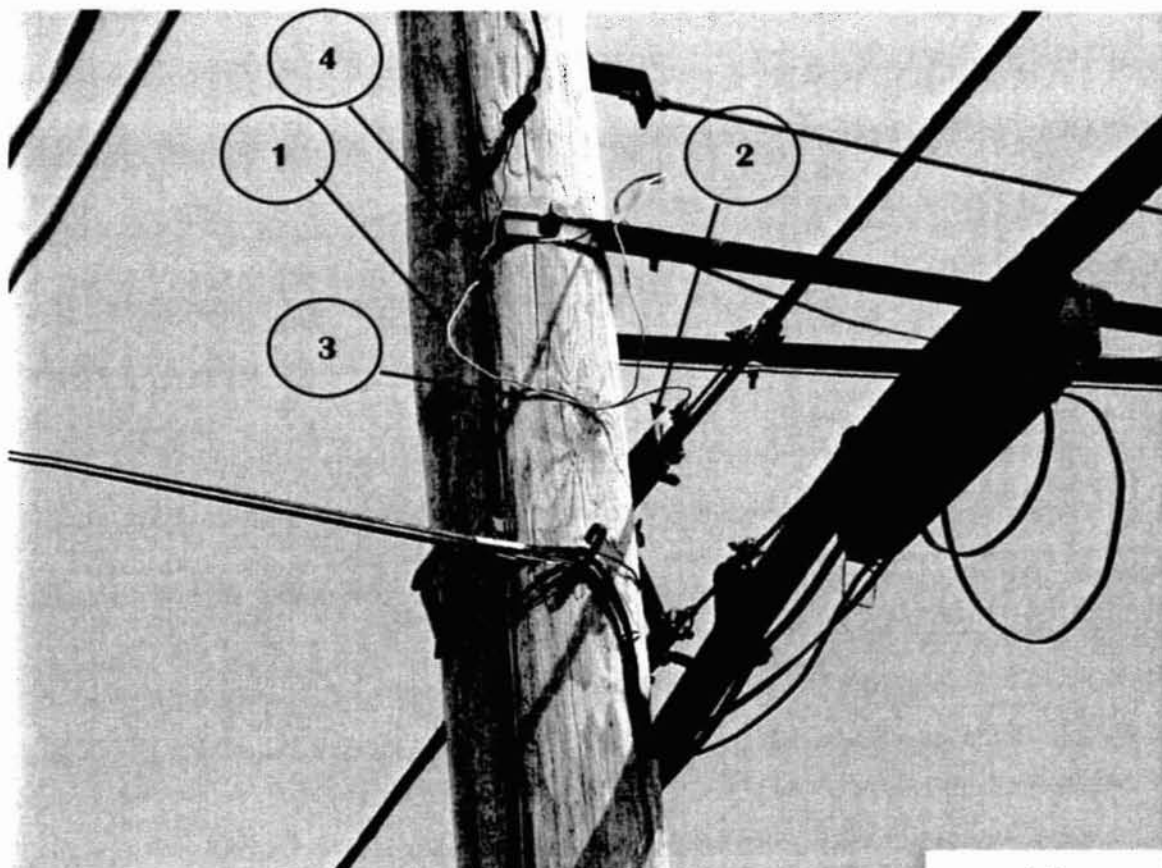
- 41A -

This photo, which I took, shows a street light which EAI could readily have installed in compliance with the NESC but the white lead from the light (Arrow #1) runs down the pole until it almost touches the cable tv attachment (Arrow #2) and does touch the cable bond wire (Arrow #3). Then this white street light lead goes back up and connects to the EAI pole ground wire (Arrow #4). EAI has created three violations here. First, street light leads must be 12" above CATV. Second, the white neutral lead must connect to a neutral conductor (wire) not a pole ground wire. Third, the street light bracket must be grounded, or, the bracket must be 20 inches from cable. EAI's contractor, USS, which inspected this pole has seldom noted a street light grounding violation and never noted an incorrectly connected neutral. These numerous violations of the basic provisions of the NESC create real hazards to communications workers and electric workers alike and are the responsibility of the electric company to correct. Jacksonville, AR. N. First St.

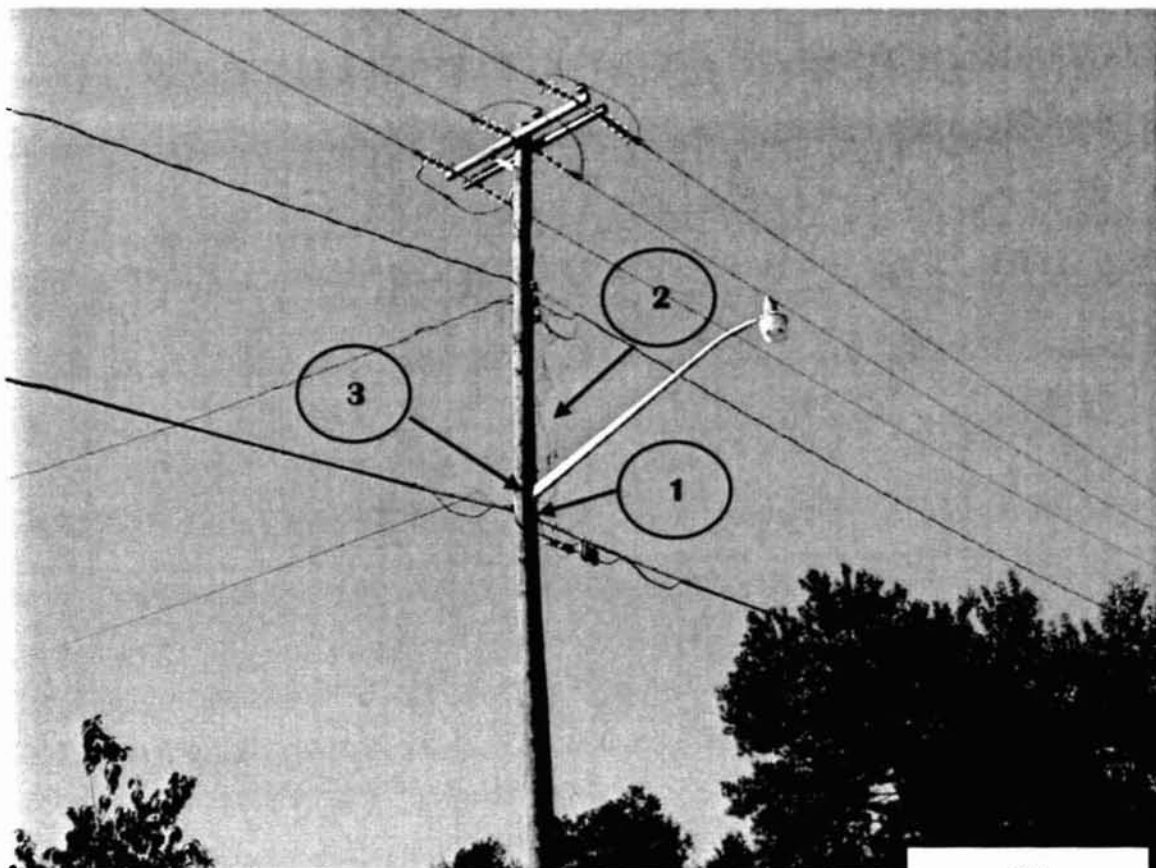
- 42A -

This photo, which I took, shows a street light placed much too close to cable (Arrow #1). One hot wire lead (120 v.) hangs down alongside the pole (Arrow #2). The neutral wire for the light is connected to the pole ground at the same level as the cable television attachment. The bracket is not grounded (Arrow #3). There are four significant EAI violations at this location: (1) the street light leads are less than 12 inches to cable; (2) the bracket is grounded and is less than 20 inches to cable; (3) the neutral is connected to pole ground; (4) the long, hot wire is not secured to the pole. Location: Little Rock Mablevale Pike.

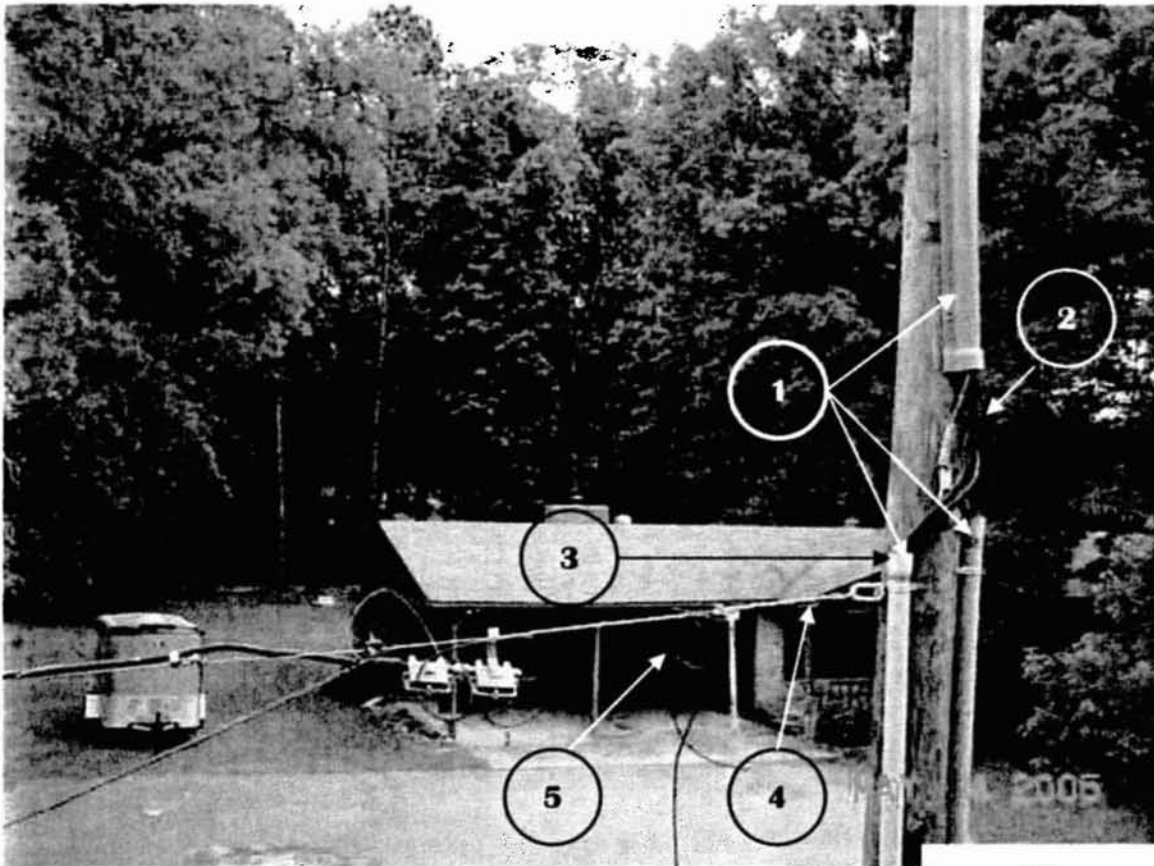
-47A-

This is a pole that Cox asked Entergy to replace for its upgrade in Malvern. It is a brand new pole, so EAI was starting with a clean slate. The first problem is that EAI has installed the riser conduits poorly (Arrow #1). The black cables visible in the photos are hot electric cables leading from a transformer at the top of the pole to an underground electric service installation (Arrow #2). The top of the conduit (Arrow #3) is about two or three inches from Cox's cable TV facility (Arrow #4). The dangling wire visible about a foot to the left of the pole (Arrow #5) is one of Cox's customer service drops that Entergy did not re-connect after it replaced the pole and took the liberty to transfer Cox facilities. Another major problem is that this is a dead-end pole, that EAI did not guy. All dead-end poles must have guys to balance load tension.

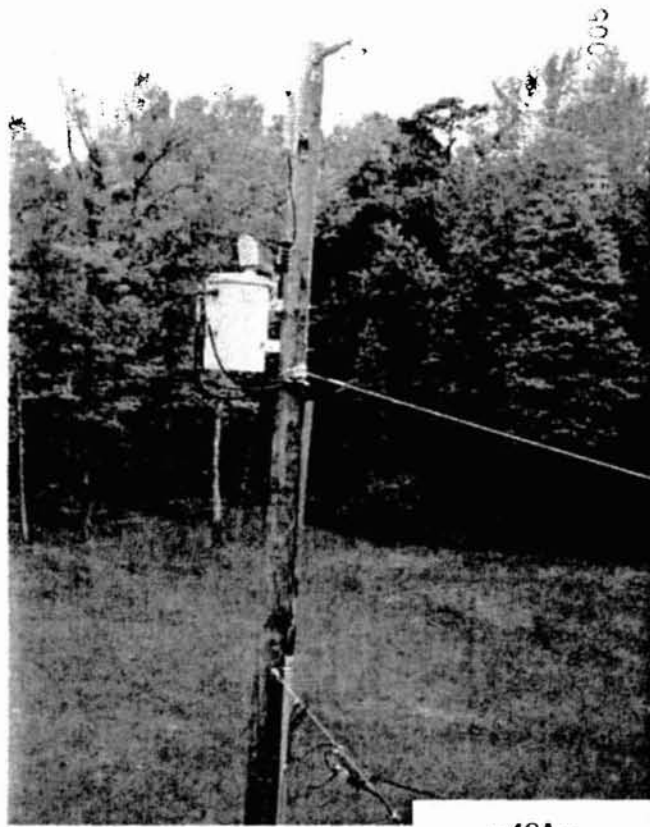
- 48A -

As is clear from this photo of the same pole depicted in the previous photo there is no guy and the pole is already leaning. This situation will get worse over time. Lines will sag, possibly creating hazards with traffic beneath the span. The pole could eventually fall down.

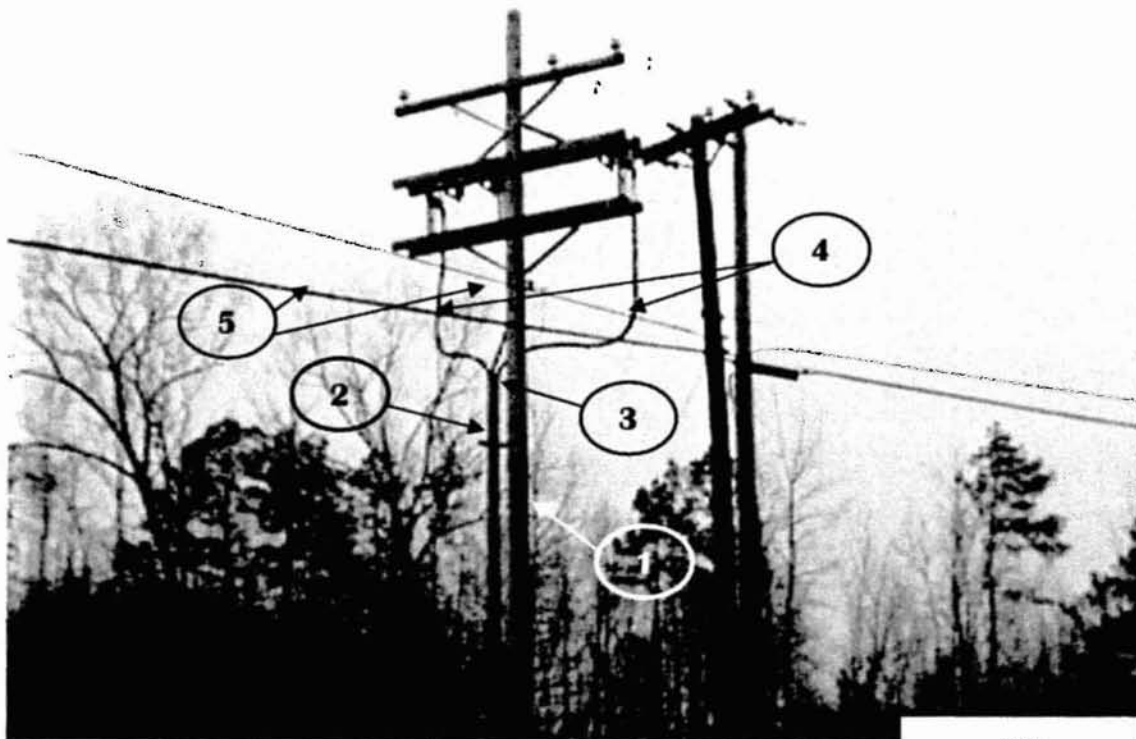
- 49A -

This new pole (Arrow #1) and high voltage primary cable riser (Arrow #2) was installed by EAI. The riser pipe (Arrow #3) stopped below cable (Arrow #4), not 40 inches above as EAI insists is their mandatory standard. The electric cable then flared out from the riser, completely surrounding the cable TV facility (Arrow #4). Comcast ultimately was able to extricate its facilities, but only by cutting them down – a very expensive and wasteful operation that could have been avoided if EAI had sought to notify attachers of this new installation and coordinate the project. This photo was taken at the direction of Marc Billingsley of Comcast.

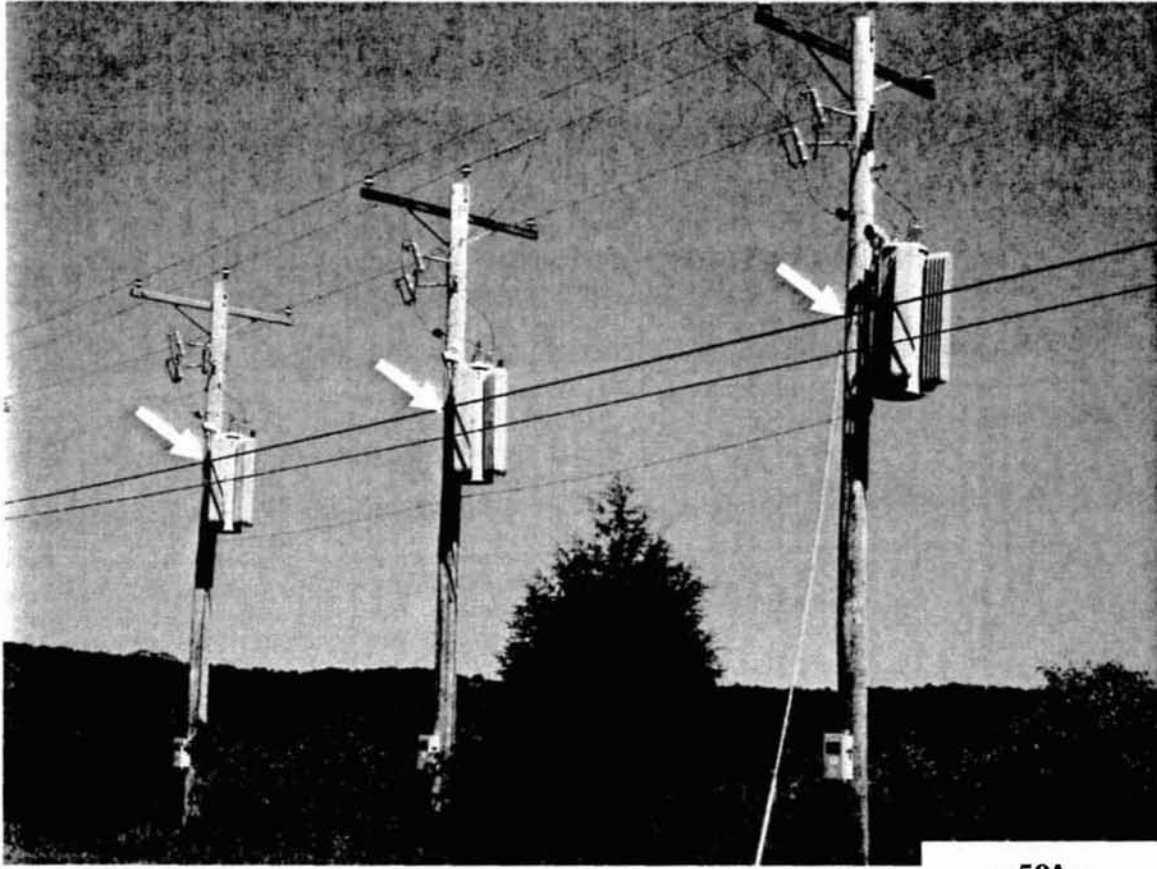
- 50A -

These photographs were taken at the direction of Jeff Gould of Cox in that company's Russelville system. Here, the power company very recently has (1) installed new poles; (2) put up three step voltage regulators, and (3) put the regulator tanks into direct contact with the pre-existing communications lines. The communications cable near the top of the long regulator tanks is much less than 40 inches to the exposed high-voltage wires and connections on top of the regulator tanks and within easy reach of workers and sudden death. In addition, the neutral that according to EAI must in all cases be 40 inches *above* communications, EAI actually installed several feet *below* communications. But the communications lines are not connected to these poles and are merely rubbing against these regulator tanks. This is obvious from the next photo.
